RL-TR-96-98
Final Technical Report
July 1996

RELIABILITY ASSESSMENT OF OPTO-ELECTRONIC INTEGRATED CIRCUITS

Uniphase Telecommunications Products

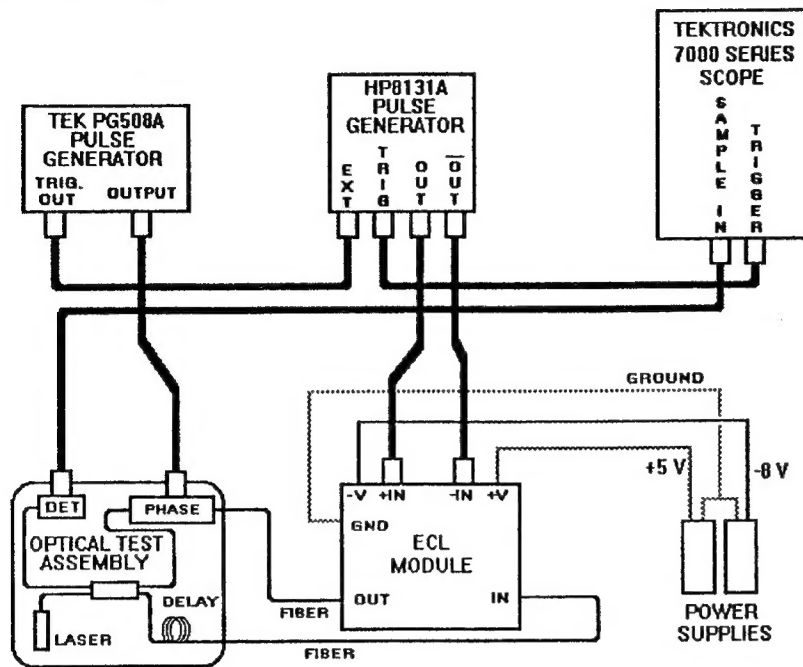
Figure 1: ECL modulator test set-up.

Figures 1 and 2 show the test set-up used to evaluate the ECL modulators and BCM devices. A more detailed explanation of testing procedures can be found in the OEIC Reliability Test Plan.

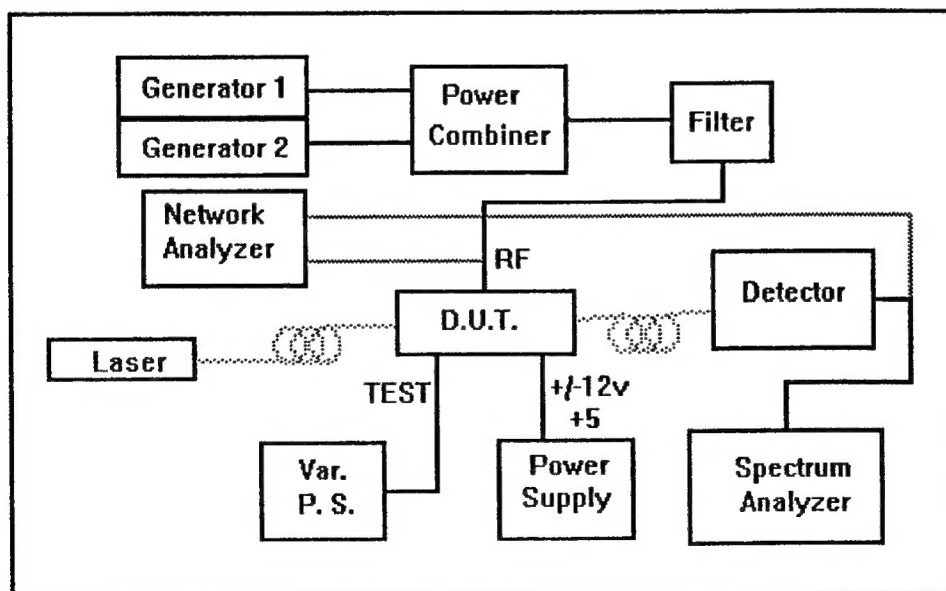
Figure 2: BCM device test set-up.

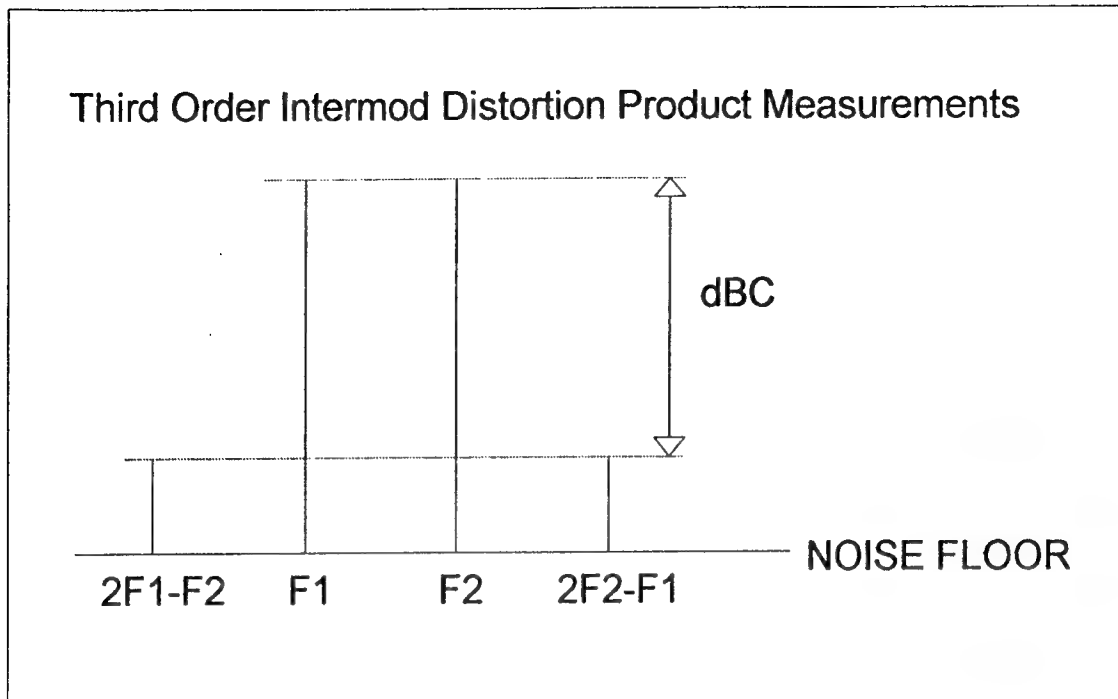
Figure 3: Intermodulation measurement.

4) Half-wave voltage, V_{π} , was always measured to be below 1.06 V for all BCM devices. No trend was observed for V_{π} vs. exposure time. In some cases, the measured V_{π} dropped to abnormally low values. For example, in Lot 2 the V_{π} was measured to be 0.4 V at 250 hr and then returned to approximately 1.0 V at 500 hr. These dropouts in V_{π} are likely to be an artifact of measurement. V_{π} is measured from the relative level of the 3rd order IMP's (Inter-Modulation Products), which are illustrated in Figure 3. The formula used to calculate V_{π} from the 3rd order IMP, given by Equation 2, assumes an ideal bias point. In that equation, V_{rms} is the RMS voltage of the applied tones and D is the level of the 3rd order IMP relative to the main tones. The level of the 3rd order IMP increases when the bias point moves away from the ideal, causing D and the measured value of V_{π} to both decrease. The bias point was off by 76° when V_{π} was at its measured value of 0.4 V; therefore, the V_{π} drop is probably a measurement artifact. Another contributor to measurement error is noise which creates uncertainty in the small signals levels of the IMP's. These error sources can be eliminated in the future by using a more direct means of V_{π} measurement. For example, V_{π} can be measured at the same time that the modulator extinction measurement is made, by recording the difference in applied voltages for the on and off states.

$$V_{\pi} = \frac{\pi \cdot V_{rms}}{2 \times 10^{-D/40}} \quad (2)$$

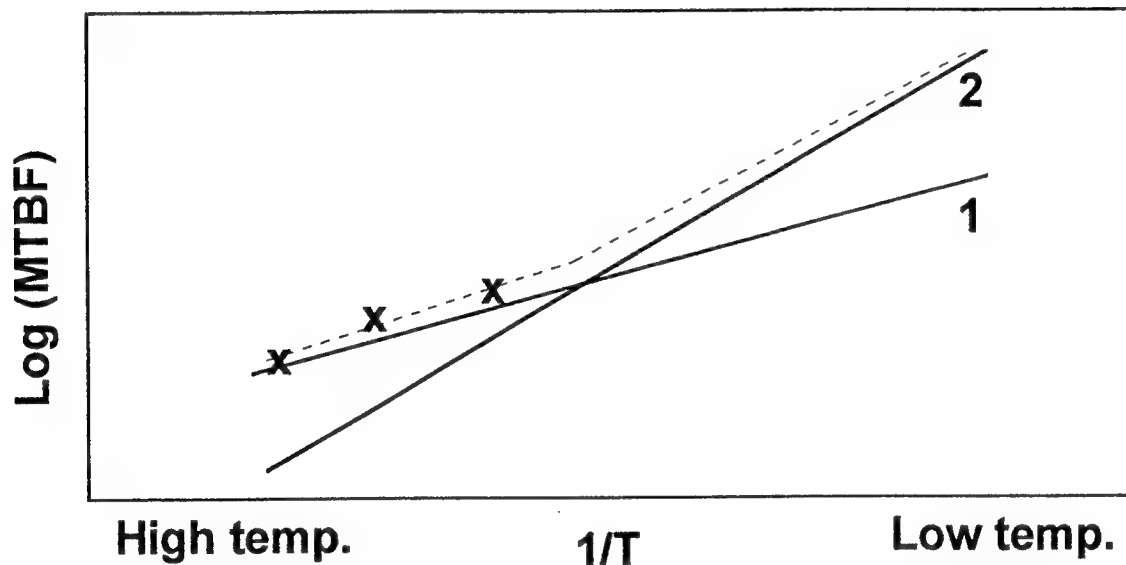
Figure 4: Illustration of two step failure mechanism. Solid lines represent Arrhenius plots of actual MTBF for each failure mechanism. Dashed line represents overall MTBF, which is sum of MTBF's from each step. Crosses represent measured data from which extrapolations are made.

The optical failures were assumed to follow an Arrhenius model for thermally activated processes. It should be noted that this simple model maybe an oversimplification of the failure mechanism. The BCM optical failure may occur in two steps, the first being package seal failure; the second being pigtail failure. In this case, the overall MTBF is

simply the sum of the MTBF's corresponding to seal failure and pigtail failure. The epoxies used for package sealing and pigtailing are different and are likely to have different MTBF and activation energies. If one step occurs much faster than the other than the MTBF will be approximately determined by the activation energy of the slower process. It is possible that in the temperature range where testing was performed, one process (say package seal failure) is the slower step, while at room temperature the other step (say pigtail failure) is the slower step. As can be seen in Figure 4, extrapolating to room temperature can lead to an erroneous result; however, the error creates an MTBF that is more conservative (shorter) than actual. In this analysis, it was not possible to separate seal failure MTBF from pigtail failure MTBF; therefore, one activation energy was used in the model.

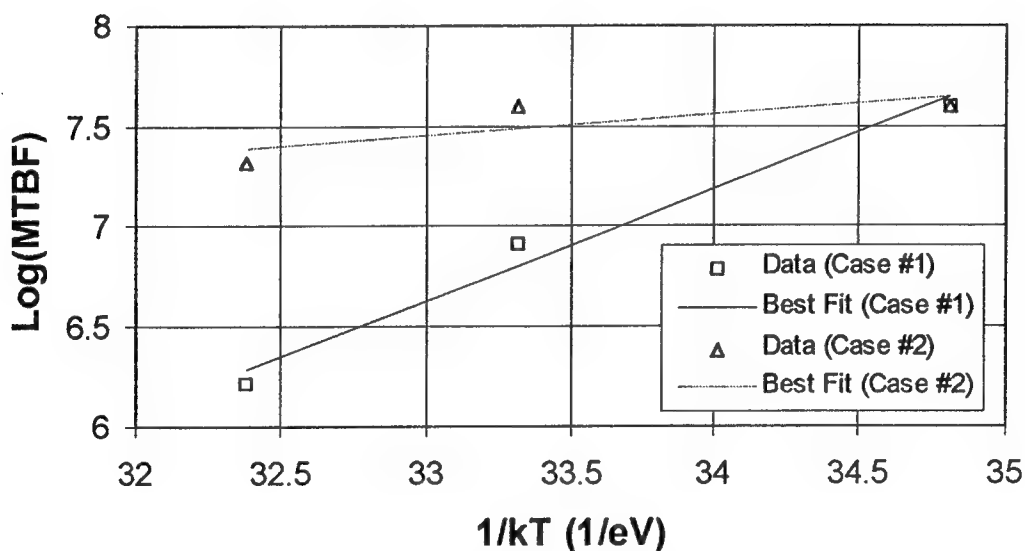
Figure 5: Arrhenius plot of MTBF data and least squares straight line fit. Case #1 and #2 use minimum and maximum possible values MTBF at high temperature, respectively.

The MTBF can be estimated at lower temperatures, by making an Arrhenius plot of the data, performing a least squares straight line fit, and extrapolating the least squares fit to lower temperatures. Uncertainty in measured MTBF at the higher temperatures can have a dramatic impact on the estimated MTBF; therefore, the extrapolation is performed for two extreme cases. Case #1 uses the minimum values for MTBF for Lots 3 and 4, whereas Case #2 uses the maximum values for those lots. It should be noted that the uncertainty in the MTBF at 75°C / 90% RH actually has a minor effect on the least squares fit, influencing the value at 25°C by less than 1%. The estimated MTBF at lower temperatures is mainly influenced by the values assumed for Lots 2 and 4. Figure 5 contains the Arrhenius plots of the MTBF data including the least squares fits. The measured and straight line fit MTBF are given in Tables 12 and 13 for the two cases and the activation energies are listed in Table 14. The MTBF from 25°C to 85°C is plotted in Figure 6. Note that the uncertainty in measured MTBF at higher temperatures creates large uncertainty in the estimated MTBF at lower temperatures. For example, MTBF at 25°C / 90% RH is estimated to be between 3200 hr and 20600 hr (2.3 yr).

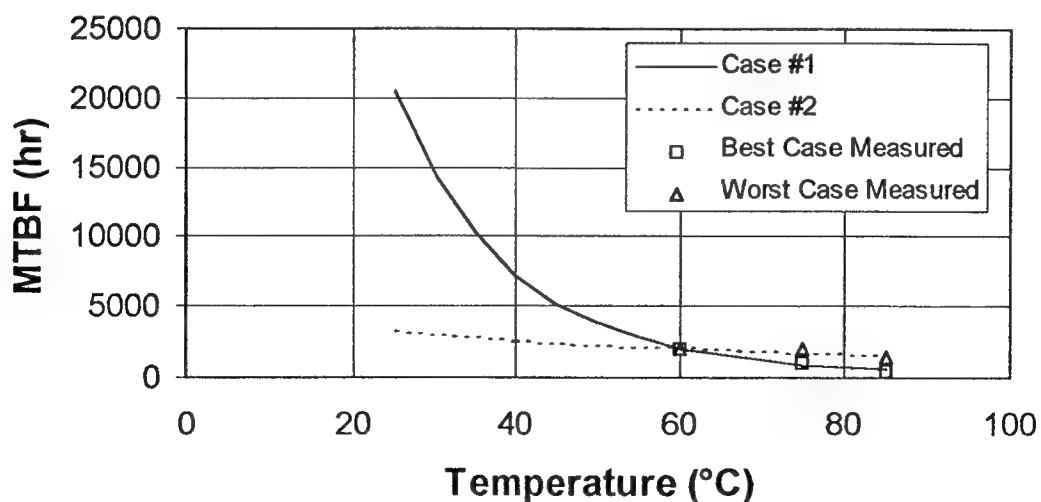
Figure 6: Plot of estimated MTBF at 90% RH for case #1 and #2, two extremes of possible values for MTBF, along with measured data. See text for explanation of large uncertainty in estimated MTBF at low temperatures.

The statistical impact of the small number of devices in each lot needs to be addressed. If the failure time for each device was accurately known, the distribution of failures with time would also be known, allowing an uncertainty in each measured MTBF to be determined. Given the small lot sizes and large time between measurements, this issue can only be addressed qualitatively. All of the devices in Lots 3 and 4 went from completely functional, with no detectable loss, to completely non-functional, that is, not passing light. The similarity of behavior suggests that the statistical effect of small lot size is much smaller than the uncertainty caused by the large sampling interval (1000 hr). It is possible that all the failures occurred abruptly over a period of a few hundred hours or less. Stated differently, increasing the size of the lots would not have changed the result much. All would have been functional at the start of the exposure period. All would have failed at the end. Lot 2 behaved differently in that the degradation occurred more gradually. One failure took place between 500 and 1000 hr and another failure occurred between 1000 and 2000 hr. The failures are likely to occur over a much larger period of time, perhaps 1000 hr. The impact on MTBF is significant. An uncertainty of 500 hr in the MTBF for Lot 2 translates into a factor of 2 uncertainty in the MTBF at 25°C / 90% RH.
